# UNDERWATER BRIDGE INSPECTION REPORT

STRUCTURE NO. 9360

CSAH NO. 122

MISSISSIPPI RIVER

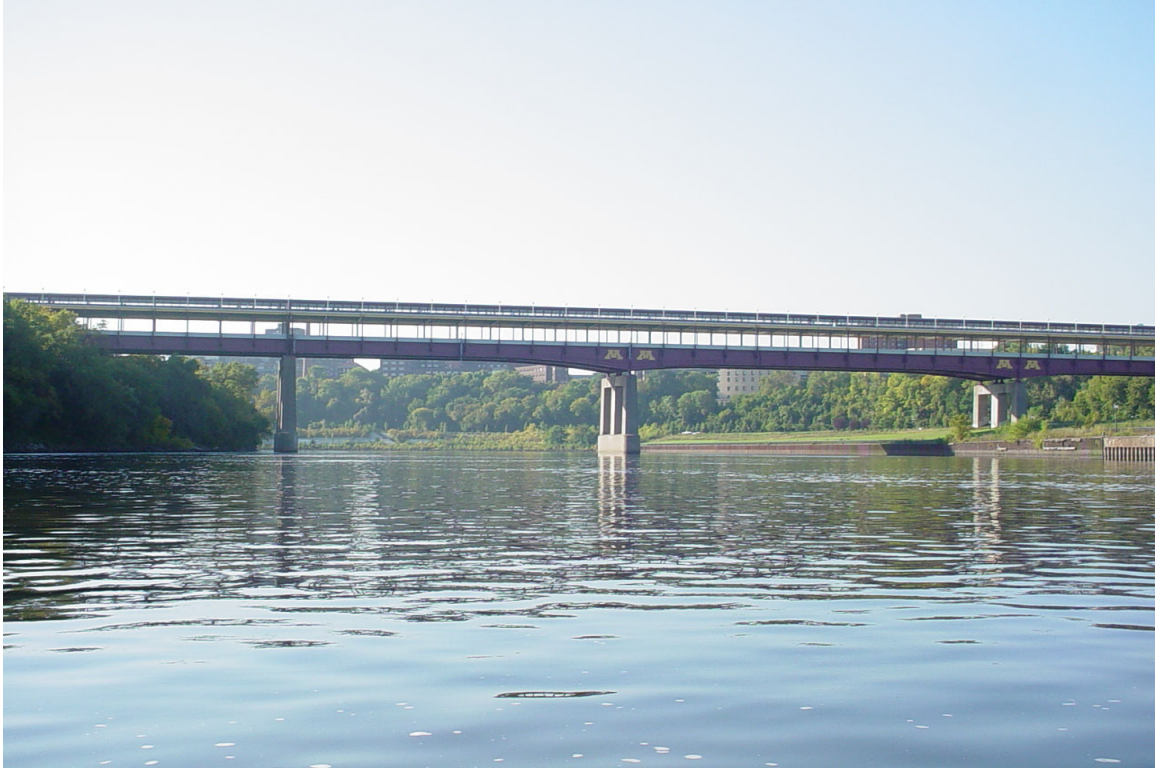
Photograph 1. Overall View of the Structure, Looking South.

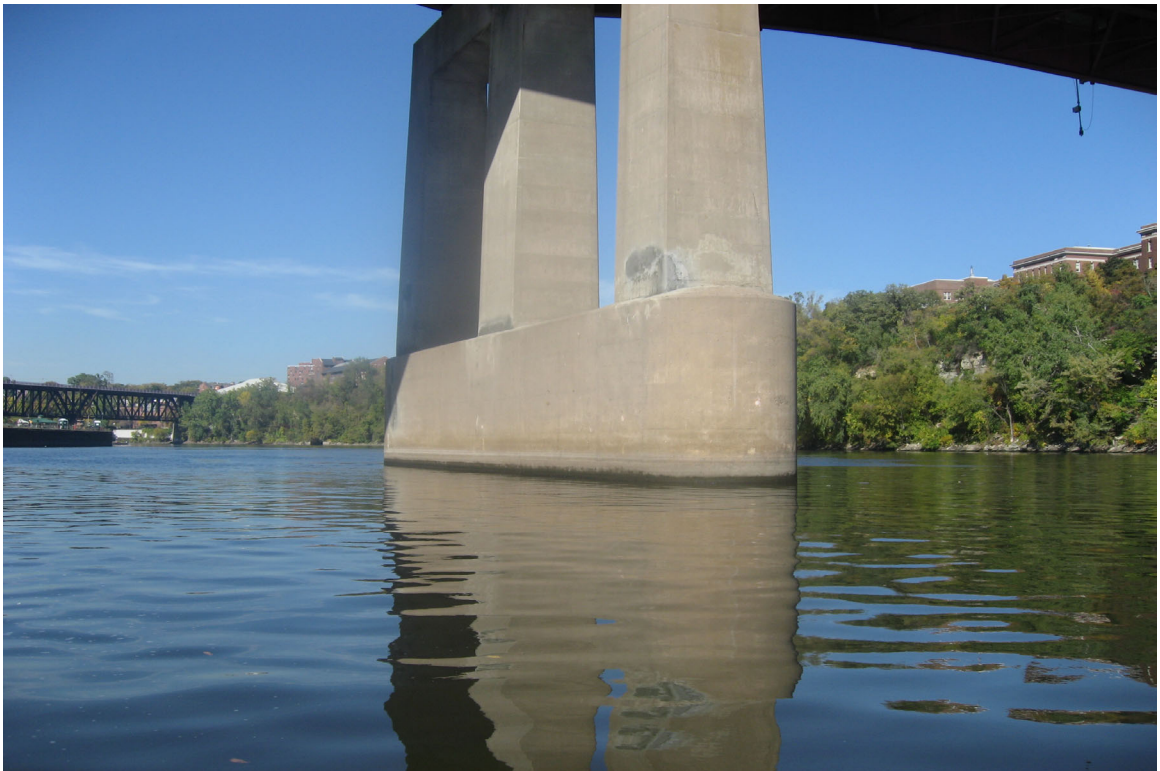
- (A) All along the east side of the West Pier, the footing was exposed with a maximum vertical face exposure of 3 feet. Sheet piling was observed along the edge of the footing and reinforcing steel was protruding from the top of the footing.
- (B) The footing of the East Pier was exposed at the northwest corner, over an area 4 feet wide by 10 feet long, with a maximum vertical exposure of 1 foot.
- (C) A minor accumulation of 4 to 6 inch diameter timber debris was observed around the upstream nose of the West Pier.
- (D) Random scaling (heaviest at the upstream noses of both piers) was observed from the waterline down 3 feet, with a maximum penetration of ½ inch.
- (E) Vertical hairline cracks with efflorescence were observed extending from the top of the webwall to the waterline with 1/16 inch maximum width.

Photograph 2. View of West Pier, Looking Northeast.

- (A) No plans for the structure were available at the time of the inspection. It is recommended that existing plans be reviewed to determine the foundation type and depth at both piers in regard to the footing exposure. Normally, the foundations of bridges on the Mississippi River are deep and/or founded on piling, which would suggest no reason for concern at this time, if that is confirmed to be the case. If not, countermeasures could be warranted, such as placing riprap around the exposed footing at both piers to prevent further exposure.
- (B) Monitor the timber debris, and if found to be increasing in the future, removal operations may become warranted.
- (C) Reinspect the submerged substructure units at the normal maximum recommended interval of five (5) years.

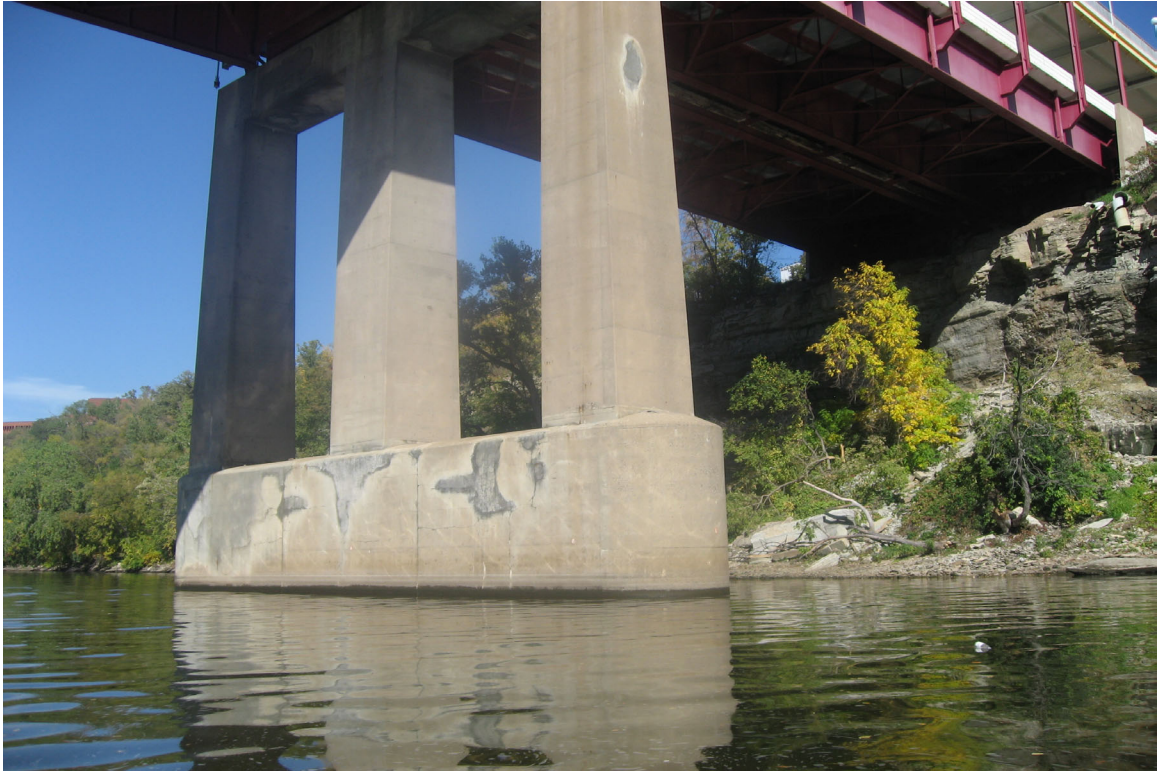
Photograph 3. View of East Pier, Looking Northeast.

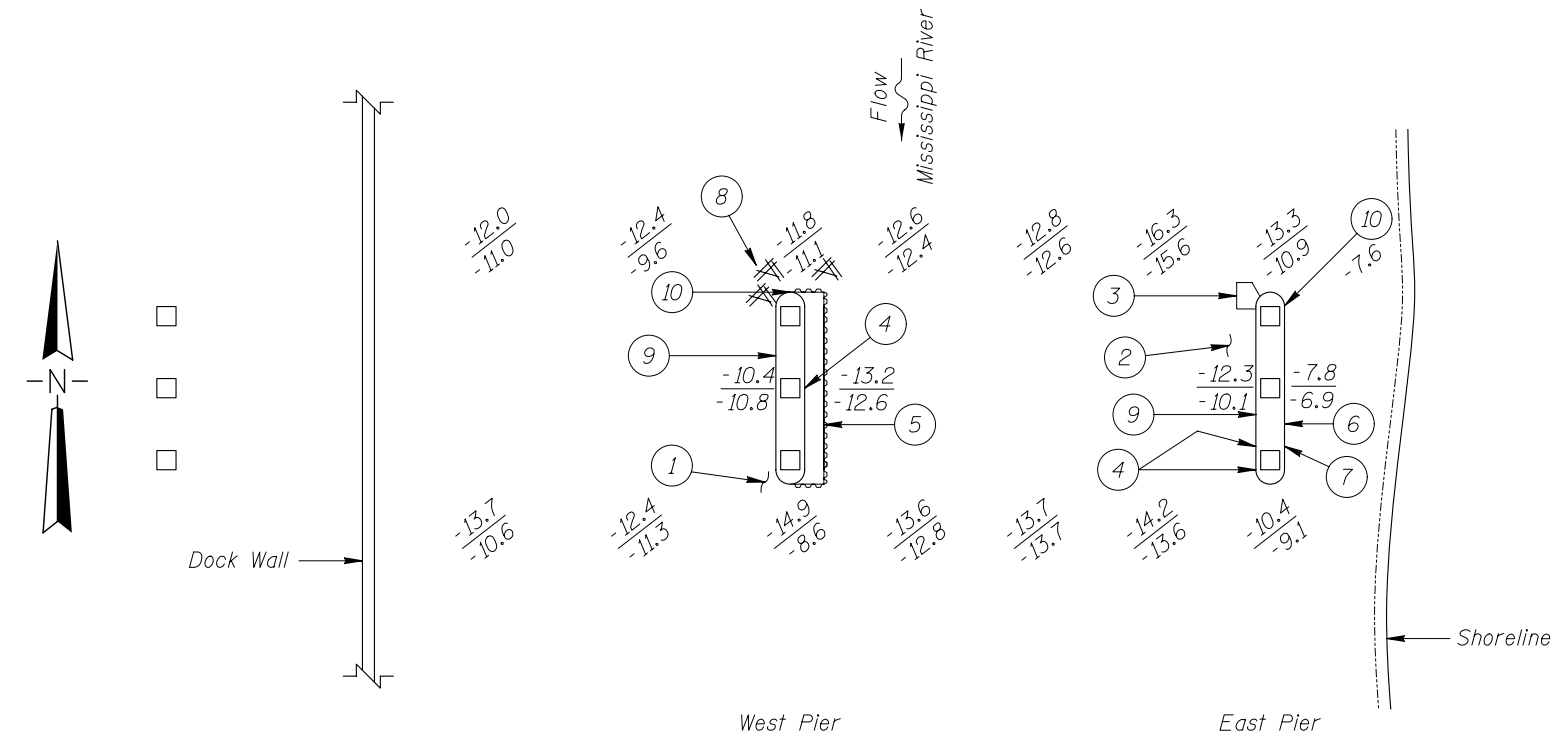
**INSPECTION AND SOUNDING PLAN**

- 1 The channel bottom around the West Pier consisted of 2 to 3 foot diameter riprap along the upstream nose. The west side of the pier consisted of sand and gravel with 6 inch maximum penetration.

- 2 The channel bottom all around the East Pier consisted of 2 to 3 foot diameter riprap.
- 3 Footing exposure at the northwest corner of the East Pier, 4 feet wide by 10 feet long, with 1 foot of vertical exposure.

- 4 Vertical hairline crack with efflorescence from the top of the web wall to the waterline with 1/16 inch maximum width.
- 5 Footing exposure all along the east face of the West Pier with 3 feet maximum vertical exposure at the downstream nose and protruding reinforcing steel.

- 6 Horizontal hairline cracks in random areas along the west face of East Pier.
- 7 A spall was observed along a joint at 1 foot below the waterline down 2 feet and was 2 inches wide with up to 1 inch of penetration.

- 8 Minor accumulation of 4 to 6 inch diameter timber debris around the upstream nose of the West Pier. Sheet piling was observed along the edge of the footing and reinforcing steel was protruding from the top of the footing.

- 9 Overall, concrete was smooth and sound with random minor areas of poor consolidation.
- 10 Random scaling (heavier at upstream noses) from waterline to 3 feet below waterline 1/2 inch maximum penetration.

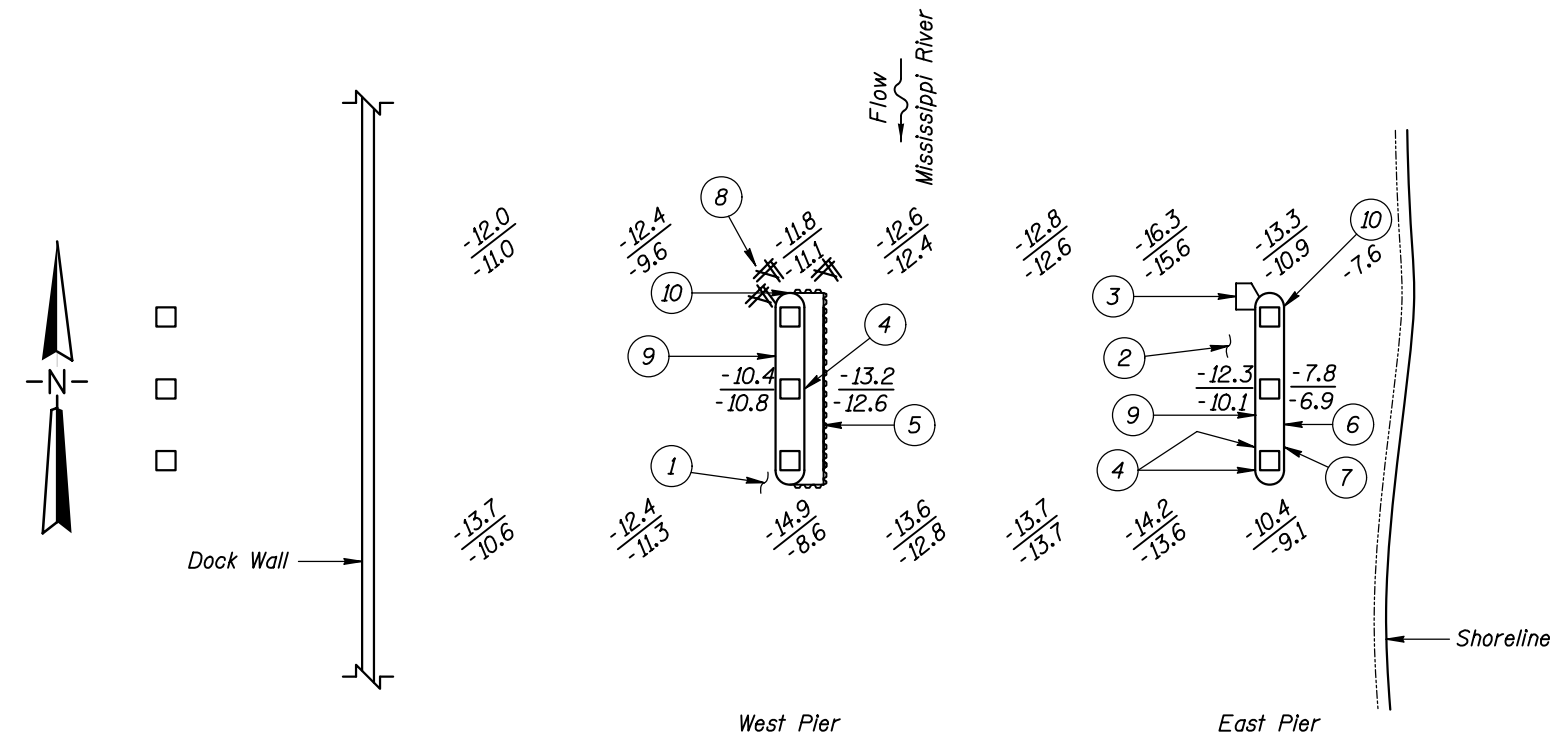
#### INSPECTION AND SOUNDING PLAN

- The channel bottom around the West Pier consisted of 2 to 3 foot diameter riprap along the upstream nose. The west side of the pier consisted of sand and gravel with 6 inch maximum penetration.

- The channel bottom all around the East Pier consisted of 2 to 3 foot diameter riprap.
- Footing exposure at the northwest corner of the East Pier, 4 feet wide by 10 feet long, with 1 foot of vertical exposure.

- Vertical hairline crack with efflorescence from the top of the web wall to the waterline with 1/16 inch maximum width.
- Footing exposure all along the east face of the West Pier with 3 feet maximum vertical exposure at the downstream nose and protruding reinforcing steel.

- Horizontal hairline cracks in random areas along the west face of East Pier.
- A spall was observed along a joint at 1 foot below the waterline down 2 feet and was 2 inches wide with up to 1 inch of penetration.

- Minor accumulation of 4 to 6 inch diameter timber debris around the upstream nose of the West Pier. Sheet piling was observed along the edge of the footing and reinforcing steel was protruding from the top of the footing.

- Overall, concrete was smooth and sound with random minor areas of poor consolidation.
- Random scaling (heavier at upstream noses) from waterline to 3 feet below waterline 1/2 inch maximum penetration.
